Rapid Vulnerability and Adaptation Assessment of Communities in Taveuni & Yanuca, Cakaudrove Province, Fiji

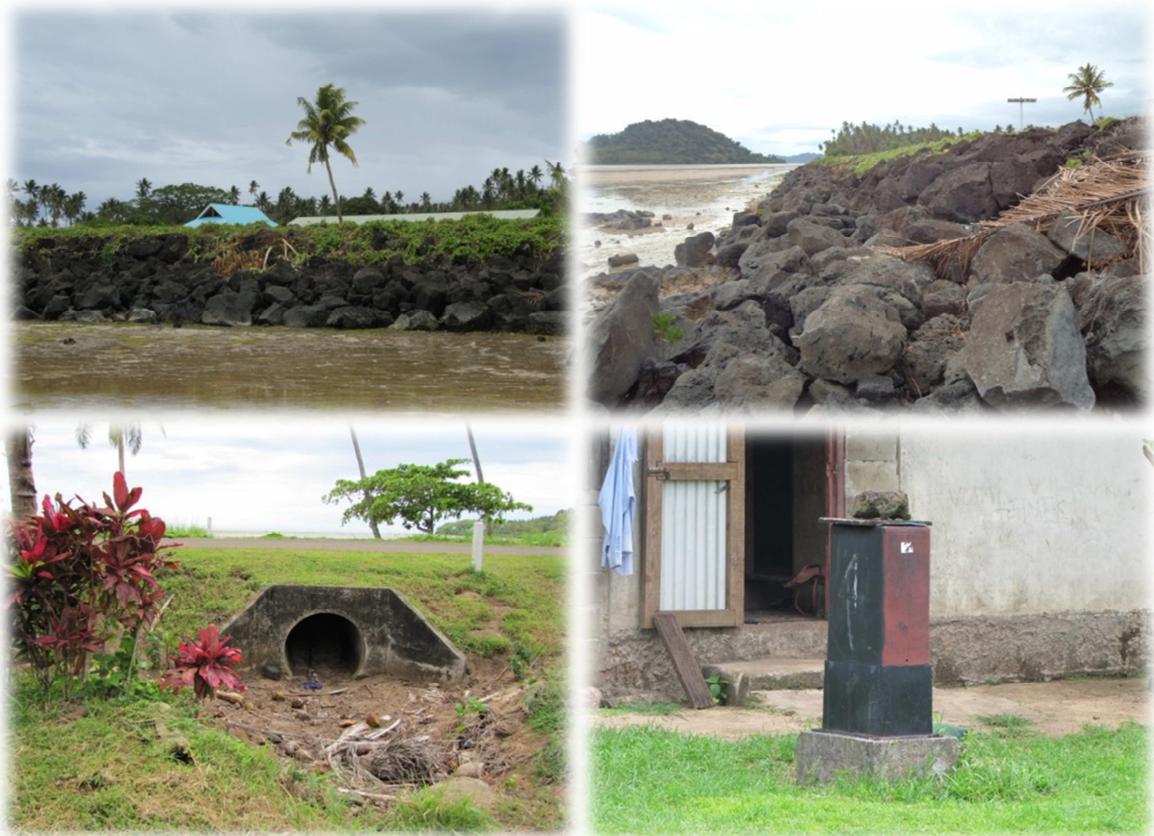
Photos of Naselesele Village, showing the seawall (top), culvert across the main coastal road (lower left) and elevated power junction box (lower right)

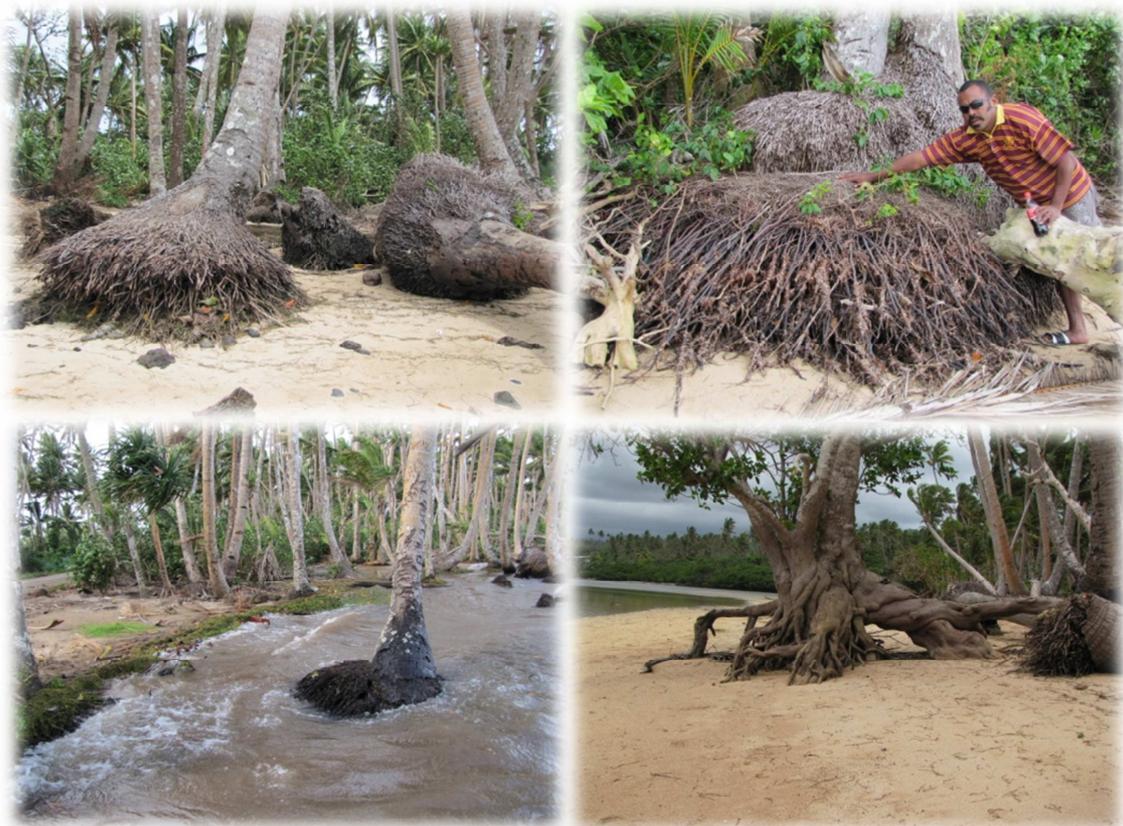
Coastal erosion was observed at Naisogo Point, caused by the intensity of Cyclone Tomas in 2010. It was observed that the shore has eroded some 30 meters, and during high tide seawater now reaches the road. The road was built in colonial time on back shore swampy ground, which is subsiding due to heavy traffic. It was also observed that much of the sand eroded from this point is accreting with ripple marks on the mudflats in front of Naselesele village. South-east trade winds are the prevailing wind pattern for this village and Navasa Point. A similar issue was identified at Navasa Point, where the road is built on back shore area and is also subsiding.

Coastal erosion at Naisogo Point, close to Naselesele Village. Clockwise from top: fallen coconut trees showing former level of sandy coastline; the area at high tide, showing proximity to the coastal road which is now at sea-level; coastal tree (*Sinu Dina*, *Excoecaria agallocha*) with exposed roots attesting to the level of the sandy beach at the site prior to cyclone Tomas in 2010.

The back shore area for Naisogo and Navasa Points was characterized by plants specific to this ecosystem, such as mangroves and pandanus. According to the *Turaga ni Koro*, the mangrove species *Rhizophora samoensis* (Tiriwai) has regrown naturally at Naisogo Point after 15 years which is indicative of replanting this species for adaptation. However study on current patterns would be helpful in understanding the dynamics of sand movement.

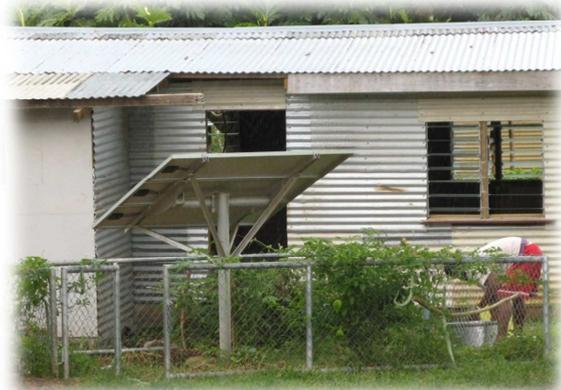
EU-funded solar panels at Qeleni Village

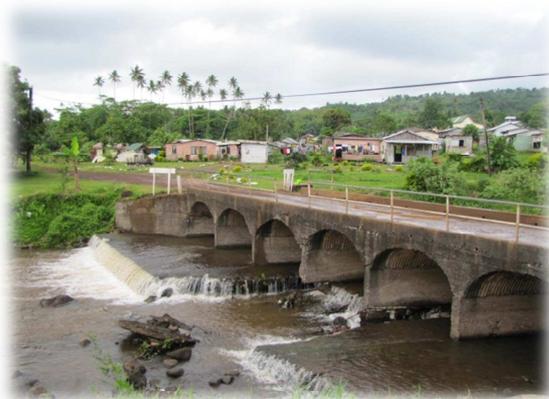
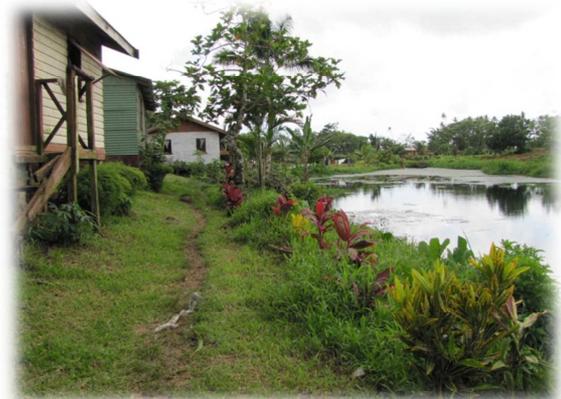
Qeleni Village and bridge (left) and low-lying areas close to the river (right)

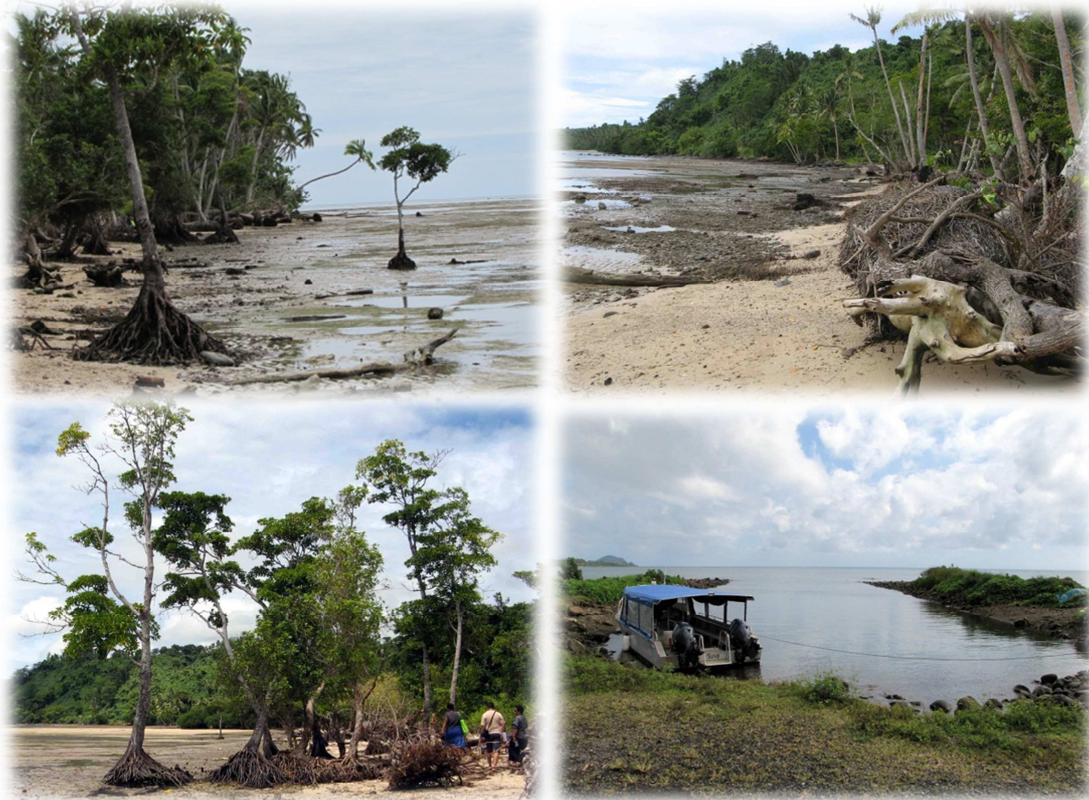
According to the *Turaga ni Koro* of Qeleni village, the issue of coastal erosion between Vunitarawau to Vunidawa Points has been aggravated by the development of the Laucala Island Jetty in 2008. This issue worsened with the intensity of Cyclone Tomas in 2010. The shore has eroded some 30 meters and the mangrove species *Bruguiera gymnorhiza* (Dogo) was evident growing on the mudflats with isolated remnants of a peat bog on the beach, along with exposed fossil reef and the stumps of fallen coconut trees some 10 meters out on the mudflats. The prevailing winds at these points are the south-east trade winds. The extreme severity of the erosion at this site could not only be due to the effect of the cyclone, but also to the continuous effect of the recently built jetty further down, which altered the current circulation patterns along the coastline. Past aerial images of this area need to be studied to compare the effects of this development prior to the cyclone.

*Extensive coastal erosion at Vunitarawau site (top left & right), presumably caused by the unrestricted construction of the Laucala Island Jetty in 2008 (lower right). Note the presence of *Bruguiera gymnorhiza* trees on the beach and mudflats (top left); this species normally occurs in the backshore area and attests to the extensive erosion that took place at this site. Fallen coconut tree stumps can also be seen up to 10 meters out on the mudflats, as well as peat and exposed fossil reefs.*

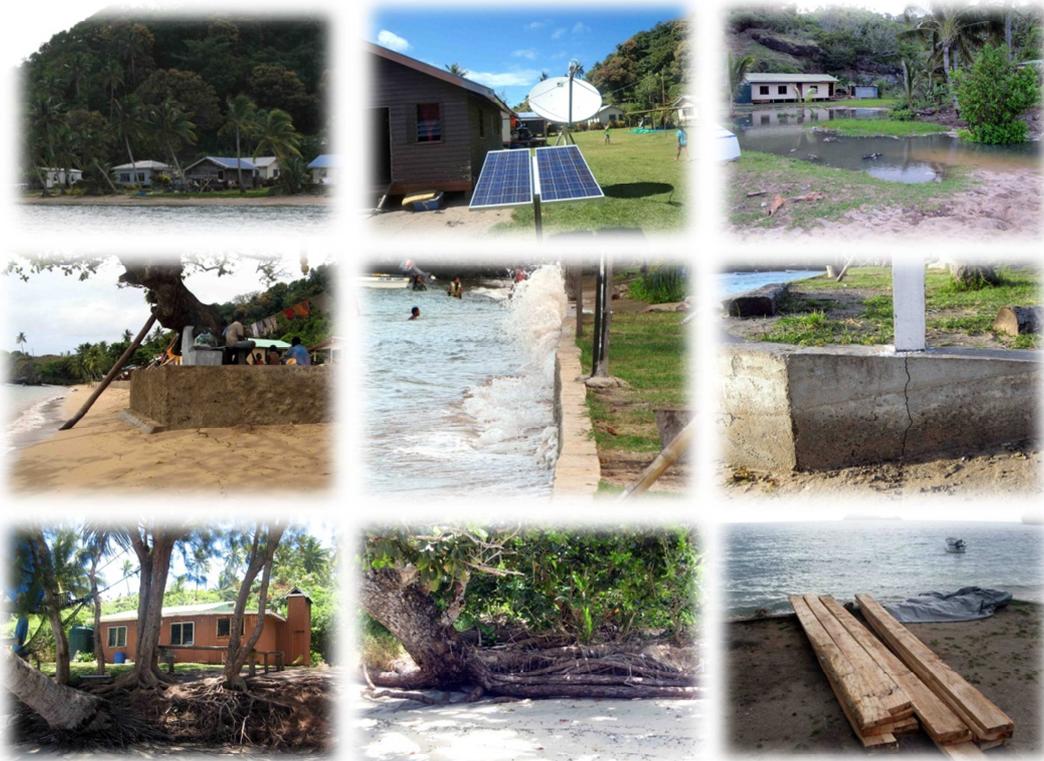
According to local inhabitants, coastal erosion in Yanuca Village has not been evident prior to the intensity of Cyclone Tomas in 2010. As a result this village has proactively built a seawall to protect their shore at a cost of FJD 10,000.00. Relocation within Yanuca itself is not an option, as the only available land for the village location is approximately 100 meters from the shore. Beyond this is the rocky central hill range of the island. While the concrete seawall was not completed at the time of our visit, cracks were already apparent in some sections. Having used stones might have been better in the long run. Some coastal erosion was seen in outlying parts of the village; however the roots of Alexandrian Laurel (*Calophyllum inophyllum*, *Dilo*) and Ironwood (*Casuarina equisetifolia*, *Nokonoko*) trees were seen to be quite efficient in retaining soil with their networked roots mitigating the effects of wave action.

Two very severe cyclones, Amy in 2003 and Tomas in 2010, washed away several structures in the village (including the church) causing extensive flooding. The narrow fringing reef and coastal plain of the island offer little protection in times of storm surges or tsunamis, with the only option being for the population to move to the hills during these events. While the environment is still relatively pristine (due to the small population of the island), logging for building by local villagers on other islets was evident. This can further aggravate deforestation and soil erosion, due to goat grazing, threatening the marine ecosystem.

Top: Yanuca Village showing hills (left) solar panels (middle) and tidal flooding (right)
Middle: The seawall of Yanuca village, at high tide (middle) and a fissure in the concrete (right)
Bottom: Coastal erosion at the village (left & middle), and local timber from logged trees (right)

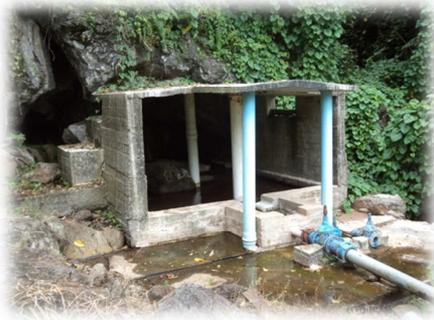
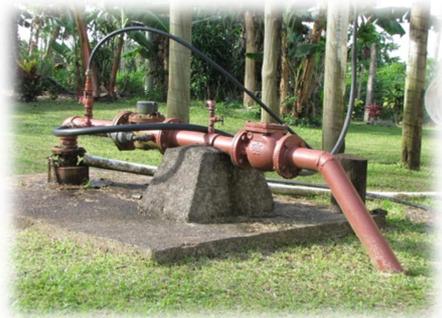
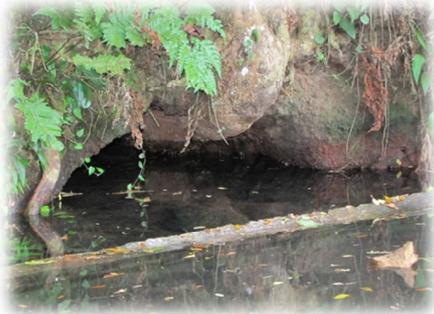
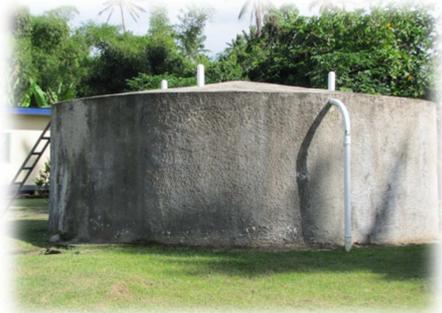
5.2.1. Naselesele Village

The WAF supplies water from the Mua catchment which is located approximately 20 kilometers from Naselesele village (Figure1). The water source is spring water which is directed into a holding cement pond of 5m (L) x 3.5m (W) x 0.5 m (D) in size. This water is pumped 8.4 kilometers into a 50,000 gallon cement water tank for treatment through chlorination drip method. This treated water is pumped 5 kilometers into two 26,000 gallon cement water tanks at Naselesele reservoir. This water is then supplied to Matei community and Naselesele village. However this catchment is not well protected with farming being evident on the slopes and surrounding areas near the catchment. On the other hand, the Naselesele reservoir and borehole is protected by fencing and a resident pump attendant. This location also has three boreholes.

In 1971 and 1975, two boreholes were constructed however due to poor maintenance and durability of the pumps, these are not currently operational. In 1991, a borehole was developed at Naselesele reservoir to supply water to other villages and nearby settlements. However due to deforestation for farming the water quality and quantity has declined (WAF pers. com.). The borehole and Naselesele water reservoir are located at 16.70483°S and 179.87497°W at an elevation of 75 meters. The depth of this borehole

powered by a diesel generator is approximately 50 meters and it is used during water disruption from Mua reservoir.

Naselesele village also has a spring source for water that has been used by past generations. This spring is well maintained with a cement wall water collection and protection. During high tide this spring is flushed with minimal seawater and is used for bathing, washing and drinking. The water resources for Naselesele are summarized in Figure 2.

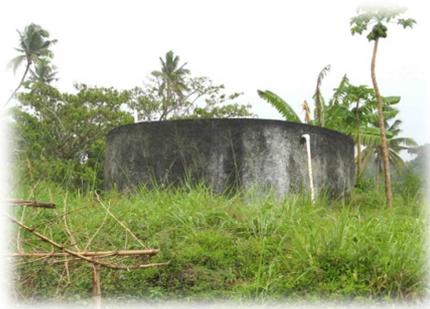
5.2.2. Qeleni Village

The current source of water supply to Qeleni village is from the upper Qeleni River, two kilometers from the village, the lower stream being used for bathing and washing. PVC pipes and gravity flow are used to deliver water to a 20,000 gallon cement water tank located within the Wainikeli District School (left). This tank supplies untreated water to Qeleni village, the school and teachers quarters. However during heavy rainfall this water supply is disrupted. Rainwater collected in water tanks is used to supplement the school during this water disruption. The school has been closed nine times in 2011 due to water disruptions (*Wainikeli District School head-teacher, pers. com., 2011*). The tanks have been provided by the Rotary Club and District Office. The village also has a spring which is used for drinking, with the lower stream being used for washing and bathing. Figure 3 summarizes the water supply for Qeleni village.

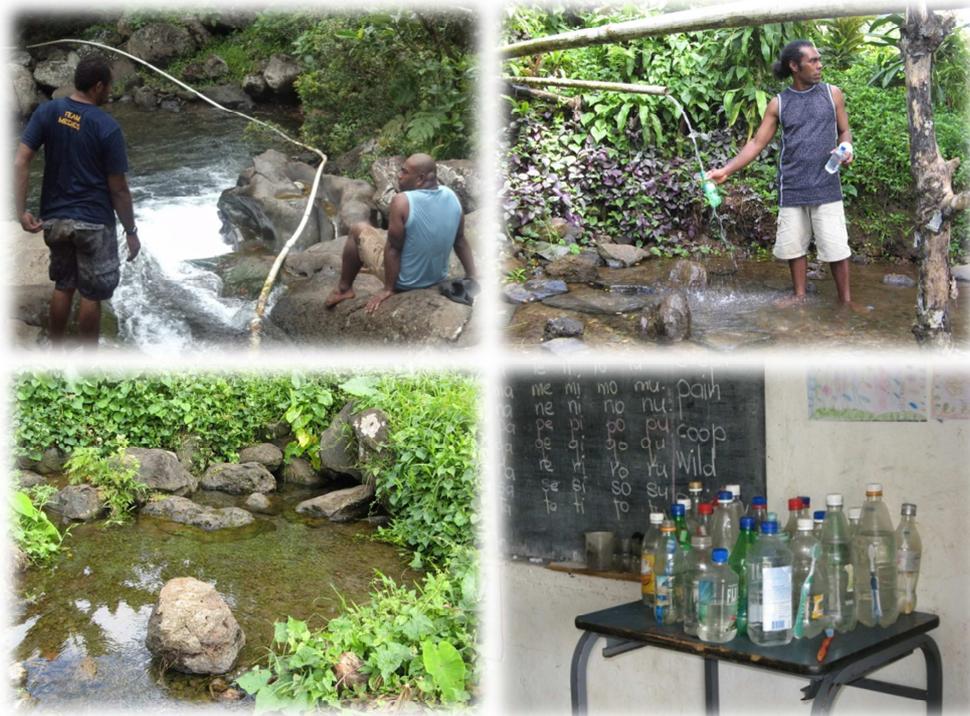
Qeleni Village area water sources. Top left: upper Qeleni River catchment. Top right: Vunitarawau spring. Bottom left: Qeleni spring. Bottom right: water bottles at school.

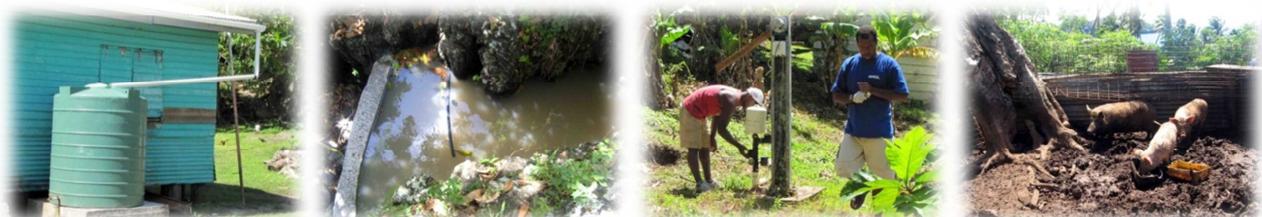
Yanuca Village water sources (L-R): rain catchment; groundwater catchment; borehole; pig sty above catchment

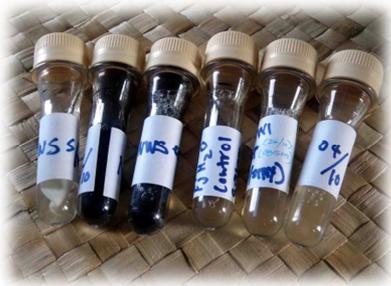
H₂S test vials for Qeleni Village

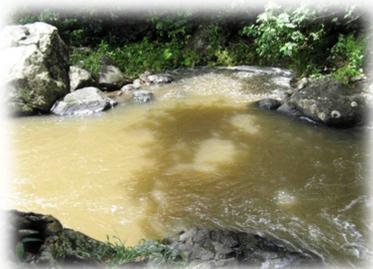
In the vicinity of Qeleni, the Vunitarawau spring showed high water quality that is due to water percolating through rocky substrate. However, the Qeleni river was found to be contaminated, and heavily charged with sediments even after a short rainfall. The village spring which most households in Qeleni village consume was found to be very contaminated. This spring is habitat for several species of freshwater algae, fishes and prawns that may contribute to sources of contamination through their feces.

Sediment load in upper Qeleni River after a short rainfall

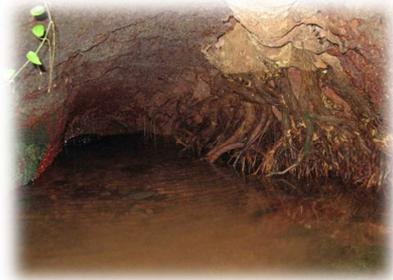
The above results highlight the variable quality of water resources at the three sites investigated. The village with the best water quality was Naselesele, which was on par with the control for both treated (WAF) and untreated (spring) water. The fact that the spring water percolates through fairly deep sediments and plant roots (photo below) would account for its high quality. However, use of this

Clean percolating spring at Naselesele Village

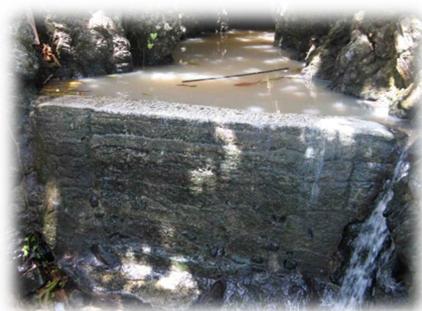
The worst water quality situation was in Yanuca Island, with all water being contaminated and the springs being charged with sediments as well. This is particularly alarming, since most households use this contaminated water for washing, bathing and drinking. The sedimentation and poor water quality is attributed to low range of hills on the island, coupled with deforestation due to

Chronic sediment load in Yanuca Island water catchment

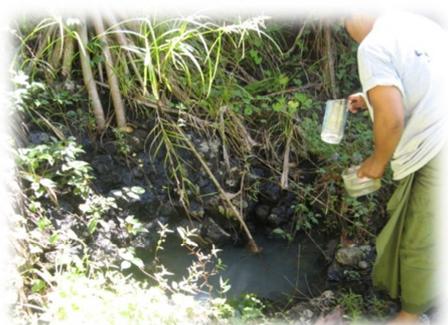
The health status for the villagers was not available from the Health Inspector at the Waiyevo Hospital. The table below, however, shows the data for children (pre-school and primary students) affected by some diseases. Water holes were tested for the presence of dengue-carrying mosquito larvae (left).

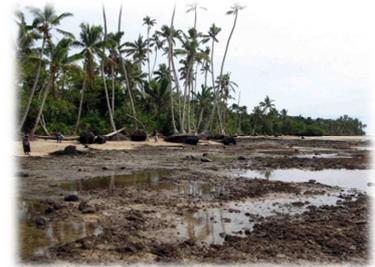
Desolated eroded coastline at Vunitarawai near Qeleni

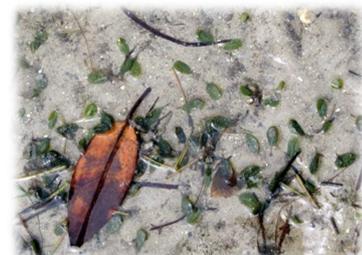
Halophila ovalis

The biggest threat to seagrass being a reduction in light penetration brought about by turbidity of the water, the destruction of coastal mangroves would have a negative impact, covering the seagrass in silt from land runoffs and coastal erosion. Similarly, excessive use of fertilizers overloads the water with nutrients, increasing turbidity and favoring the bloom of opportunistic algal species which can displace seagrass from their habitats.

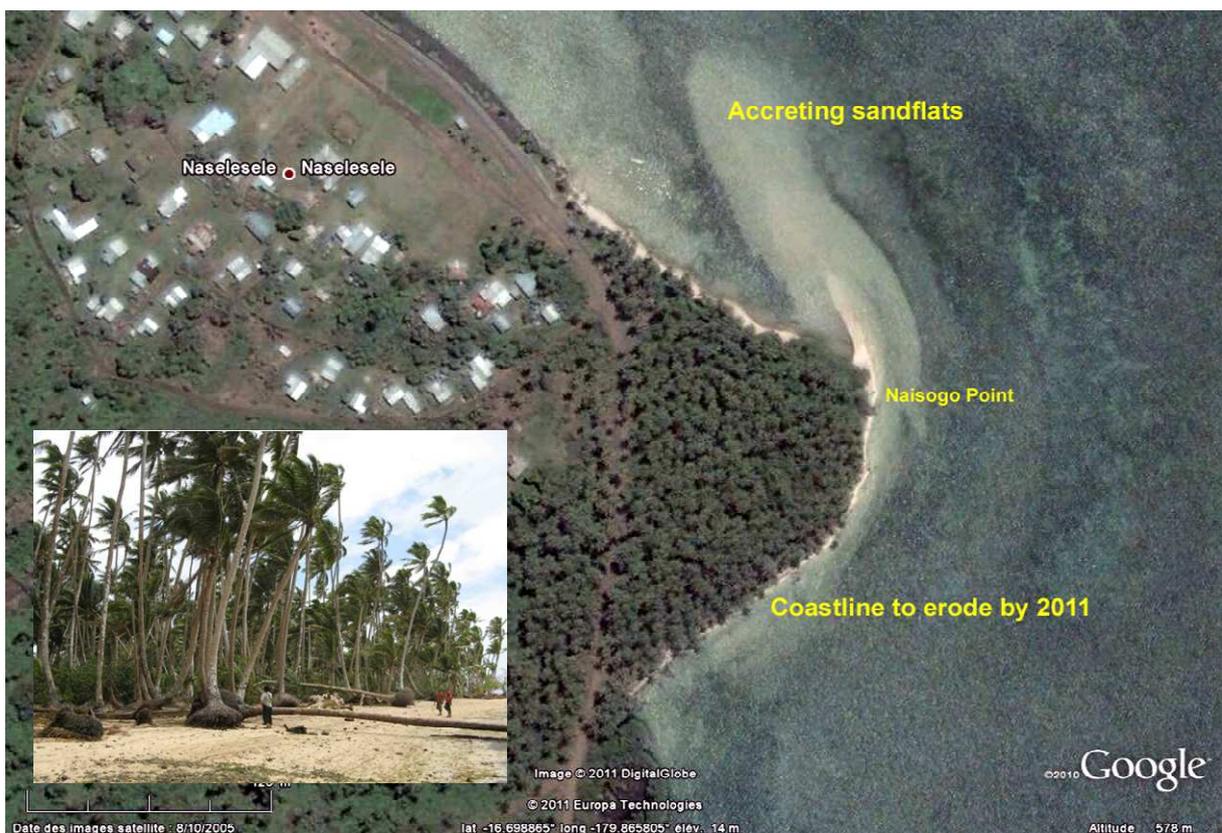
Naisogo area in 2005 (Google Earth photo) and in 2011 (inset) showing how much the coastline has been eroding following recent cyclones. The accretion of sand west of Naisogo Point is also evident.

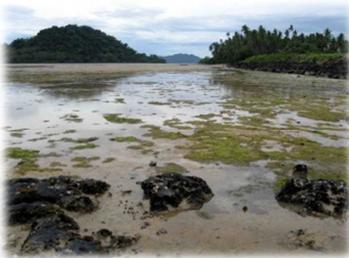
Naselesele was the richest site seen in terms of biodiversity, most likely accounted for by the wide expanses of seagrass meadows. Four seagrass species and 18 algal species were observed, as well as numerous

invertebrates and mollusks taking refuge and spawning within the seagrass beds. The sediments were mostly carbonate in nature. Oyster beds occurred near the shoreline (rock boulders). The distribution of seagrass beds was fairly uniform about 100 meters from the shoreline, although zonation was observed, with the dominant seagrass being *Halodule uninervis*, followed by *Syringodium isoetifolium*.

Accretion of sediments from the Naisogo Point coastal erosion area was noticed, forming small sandy dunes colonized by seagrass. This may smother any corals growing in tidal pools, cause necrosis of seagrass beds near the shoreline, and reduce fisheries in the area. Near the shore, freshwater effluents from the village and river were seen to cause eutrophication and mortality among seagrass beds, as well as fostering the growth of blooming green algae (*Boodlea composita*, *Ulva intestinalis*). Such blooms can displace normal populations of seagrass and algae, and altering the ecological balance of the area. Holothurians such as *Stichopus horrens* or ‘caterpillar’ have a ready market, and villagers harvest large amounts of these organisms for commercial purposes, not necessarily paying attention to size or leaving enough reproductive stock in the natural populations. The only holothurian seen during the survey was the non-

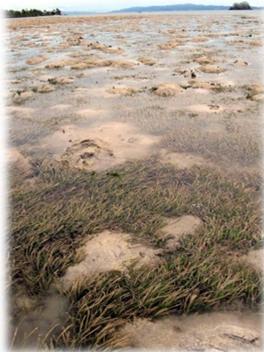
Sand dunes colonized by seagrass species

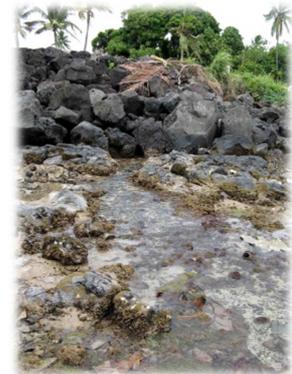
Stream outlet at Naselesele

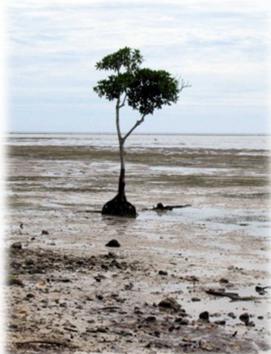
A lone Bruguiera tree attesting to the former limits of the shoreline

The extreme desolation of the coastal area at Vunitarawau, likely due to erosion of the area following the building of the Laucala Island jetty, created a distinctive marine ecosystem dominated by seagrass beds of the genera *Halodule uninervis*, *H. pinifolia* and *Halophila ovalis* subspecies *bullosa*. A total of 11 algae species were found, dominated by brown algae such as *Padina boryana* and green calcified algae such as *Halimeda borneensis*, which favor soft-sediment habitats. The intensity of erosion exposed fossil coral reefs in some places, colonized by turf

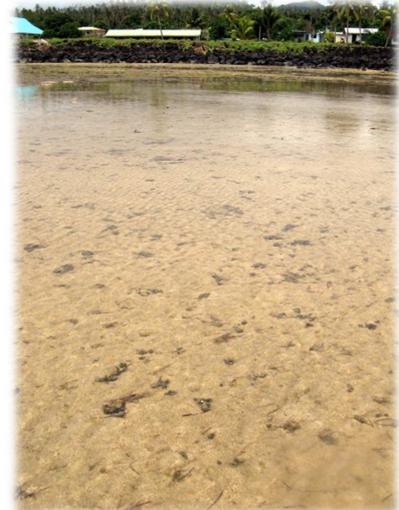
Necrosis of the seagrass Halodule uninervis at Naselesele, possibly due to excessive siltation and nutrient-rich runoffs from the village and river

1. Siltation of coastal areas from erosion and land runoffs. This was most pronounced at the Naisogo Point and Vunitarawai sites. The increased turbidity will negatively affect the ability of seagrass beds to stabilize sediments and trap nutrients, which in turn will affect the coral reefs further out, and reduce fishery catches. The planting of mangroves and trees such as *Casuarina* and *Dilo* along the coastline could reduce this problem.

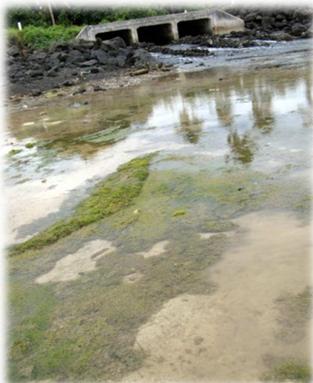
2. Pollution from domestic freshwater effluents and rivers affecting coastal marine ecosystems, leading to localized algal blooms and necrosis (mortality) of seagrass beds. In front of Naselesele Village, these effluents, as well as runoffs from agricultural lands where excessive fertilizers are likely used, was seen to cause necrosis of large areas of seagrass

Bloom of green algae near the culverts at Naselesele village

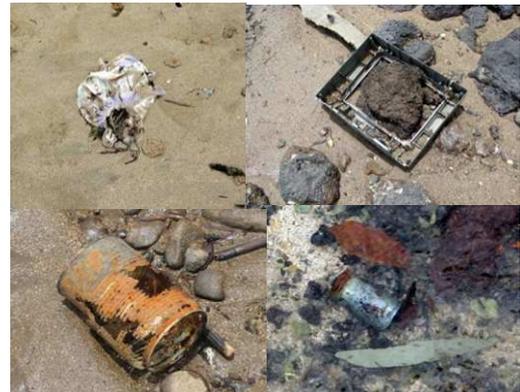
Used batteries, electronic goods, cans and diapers were seen to be dumped indiscriminately along the shoreline and on beaches at the Taveuni sites. These practices are very harmful to marine life. Toxic chemicals from batteries and electronic components slowly leak, while diapers and plastic bags can be ingested by turtles and dolphins, mistaking them for jellyfish and other prey. Discarded fishing nets can entangle fish, sharks and turtles. Educational campaigns among the communities are needed to teach them good waste disposal practices.

Household refuse seen on Taveuni shores which are toxic to marine life

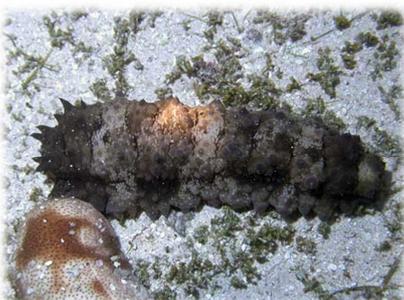
Stichopus horrens ('caterpillar')

At Naselesele, informants confided to us that recently, the fishing of Holothurians ('caterpillar', or *Stichopus horrens*) was a very popular activity as there was a ready market for these. However, the catches were getting less as the population of these mostly nocturnal holothurians were being overfished (no specimens could be seen during our survey of Naselesele flats). In

Yanuca, evidence was seen of intensive fishing for bêche-de-mer (sandfish). The depletion of holothurians can have disastrous effects on fisheries, as they are vital for enhancing the fertility and health of the seagrass ecosystems, from which a host of other marine organisms depend. The local communities need to be informed about catch limitations (protected species, size, and numbers) and the setting up of marine protected areas (MPAs) to conserve their marine resources.

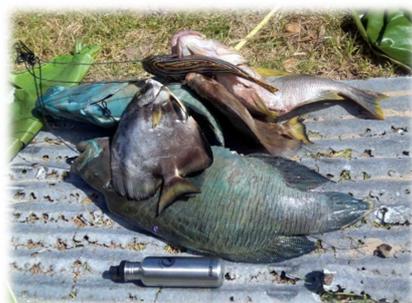
Fish catch in Yanuca, including a highly protected species

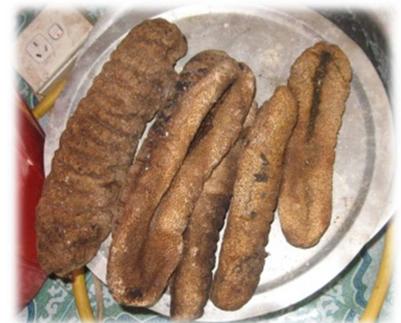
Dried sandfish at Yanuca

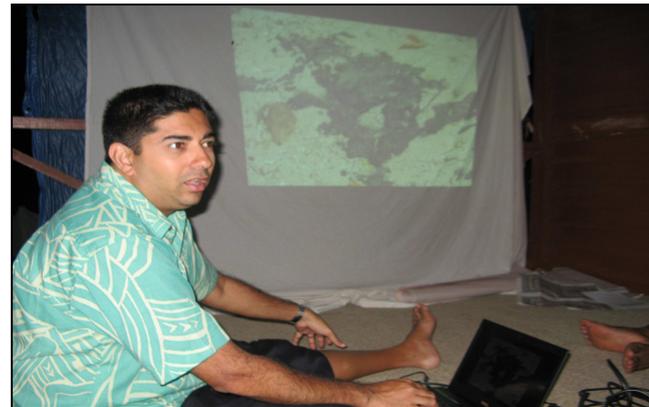
D.

Mr. Naushad Yakub (PACE-SD staff) showed to the villagers the current state of their coastline and explained the impacts of wave action during storm surges and cyclones.
