SUSTAINABLE SEAFOOD PROJECT PART 2:

Good Manufacturing Practices (GMPs) and Operational Pre-Requisite Programmes (OPRPs) Inspections of the Naduri Ice Plant.

The Consultant: Dr Jimaima Lako

December 2015

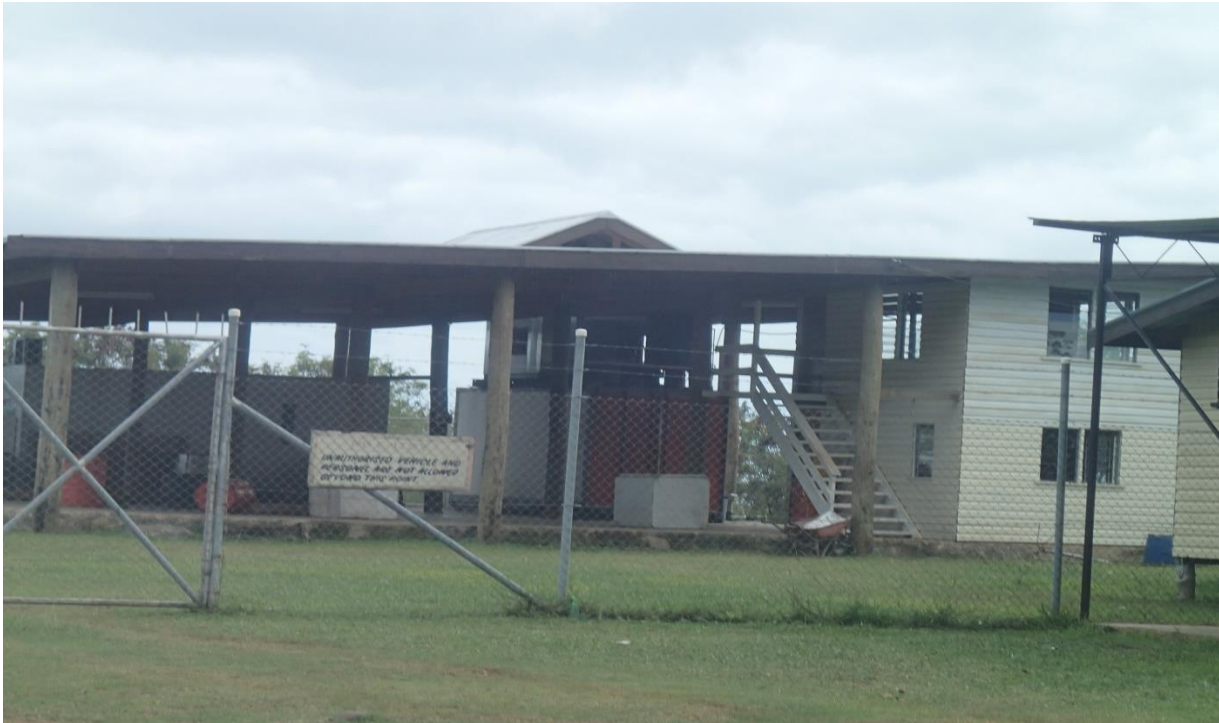
Figure 1: The Naduri Ice Plant

The Naduri Ice Plant is constructed at the beach front of the Naduri village facing the village beside the Women’s Community Shop as shown in Figure 1 below.

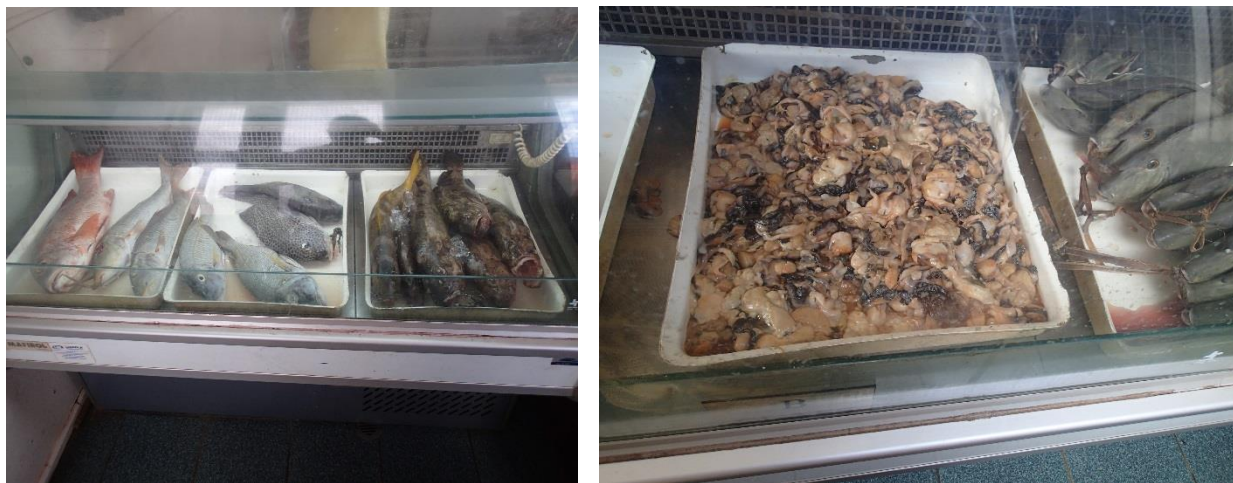
Figure 2: Fish Display Counter at the Macuata Holding Fish Shop

Furthermore, due to low demand in the purchase of ice from Naduri Ice Plant by the Macuata fishermen, the left over ice have also been transported and used at the Macuata Holdings Fish Shop display counter in the Labasa market (Figure 2). This is perhaps a potential fish market outlet for the approved Macuata fishermen which then could be processed and then sold to hotels in Viti Levu through the “Sustainable seafood project” facilitated by WWF. However, the Macuata Holding Fish Shop has to be first upgraded to work towards compliance to GMPs, OPRPs and HACCP prior to becoming the high quality central fish market outlet in Labasa from approved Macuata fishermen. A good example is the minimal use of ice in display cabinets evident by the high temperature of 7.1°C. This means that GMP and OPRP trainings for the employees need to be undertaken and as well the development, implementation, monitoring, verification and validation of GMPs and OPRPs will need to be carried out.

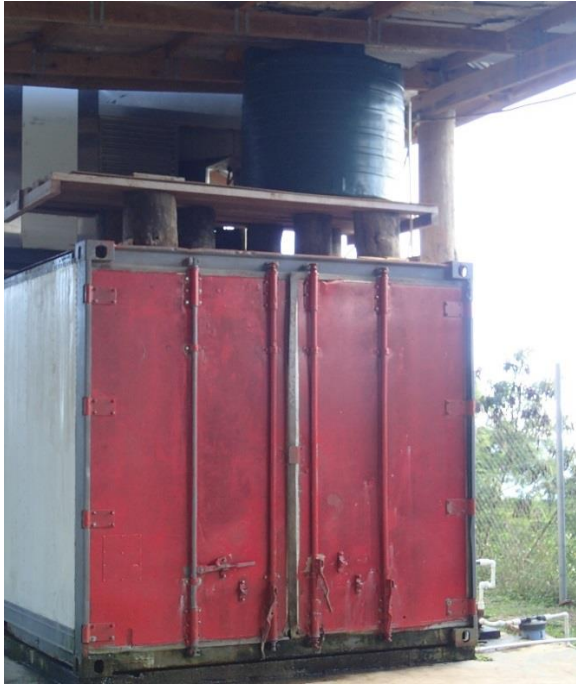
A: Ice plant external view

<i>and to be furnished with paper towel or air-hand dryer and soap and to be cleaned regularly.</i>		
8. Ice production and storage is in an enclosed room as shown in Appendices A and B. However ice contact surfaces to be food grade. <u>Recommendation:</u> <i>Ice contact surfaces to be non-absorbent, impervious food grade material.</i>		√

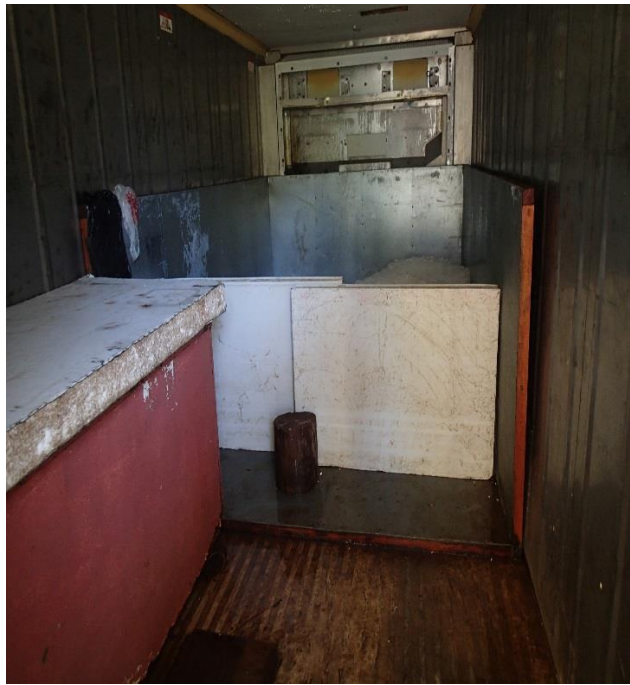
B: Ice production room

10. The table material is made of absorbent and non-durable ply-timber and corrugated iron on the sites that are rotting, corroding and rusting away as shown in Appendices B, C and D. These are difficult to clean and sanitize. <u>Recommendation:</u> <i>Ice contact surfaces to resist corrosion and impervious food grade material and that inert to cleaning and sanitizing chemicals. Stainless steel food grade material would be preferred.</i>		√

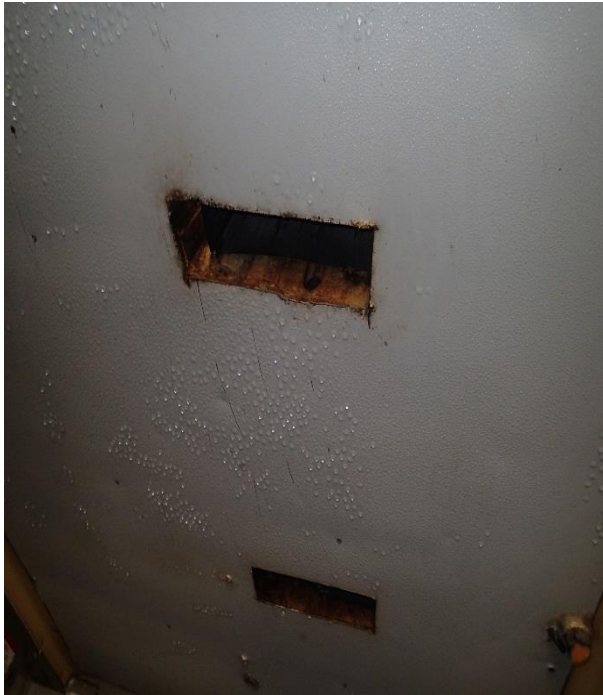
E. Ceiling of the ice production room

9. Proper construction of floors, walls and ceiling, however there is an absorbent material (sponge) at the opening where the ice drops down from the ceiling to the floor as shown in Appendices E and F. <u>Recommendation:</u> <i>Ice contact surfaces to be non-absorbent and impervious food grade material.</i>		√

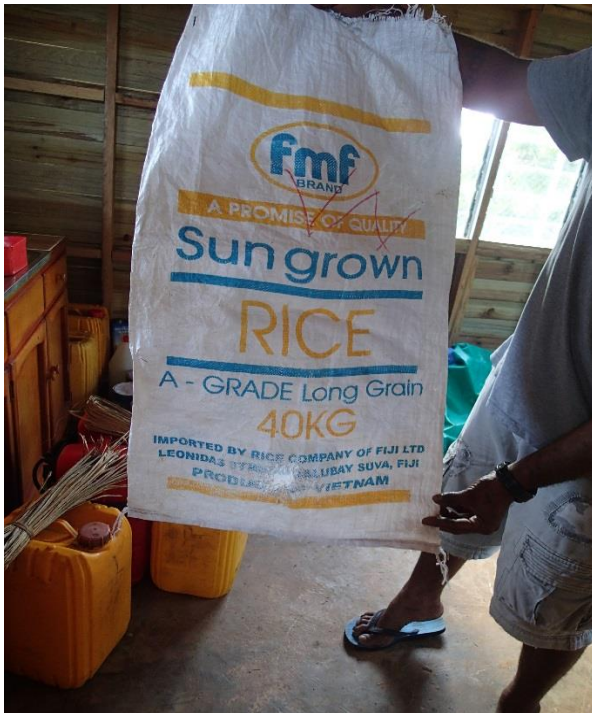
G. Ice packaging 40kg bag size

<p><u>Recommendation:</u> Cleaning records to be made available with all the standard operation procedures (SOPs) in place.</p>		
<p>15. No ice packaging are stored at the plant as fishermen provide their own 40kg-size bags as shown in Appendix G for packing ice. Hence, the hygienic status of the ice packaging will be the responsibility of the fishermen themselves.</p> <p><u>Recommendation:</u> Packaging to be provided by the Ice Plant to ensure cleanliness and safe ice to clients.</p>		√
<p>Sanitary Facilities and Control</p>		
<p>16. Water supply is sourced from the same Naduri community's drinking water supply that is not treated. No record of microbial and chemical tests results available.</p> <p><u>Recommendation:</u> Water to be tested for safety; Coliform and E.coli and to be chlorinated.</p>		√
<p>17. No hand washing observed when the employee touched the contact surfaces as the hand washing facility is not within the production facility but only available outside the building as discussed in 3 above.</p> <p><u>Recommendation:</u> The hand washing facility to be located inside and close or within the production area for easy access and needs to be upgraded with a proper wash basin and tap operated by elbow or leg and to be furnished with paper towel or air-hand dryer and soap. Wash hand signs to be posted at the hand wash stations.</p>		√

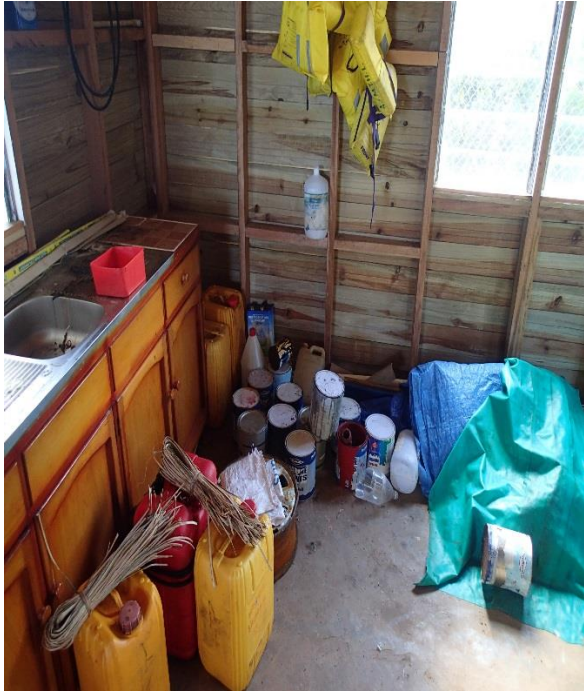
I. Storage room

11. Adequate storage space for placement of equipment and other materials available, however these are all placed on the floor accumulating dusts as shown in Appendix I. <u>Recommendation:</u> <i>Shelves to be constructed to raise the storage space for materials away from the floor for easy cleaning and to avoid harborage of pests and insects.</i>		√

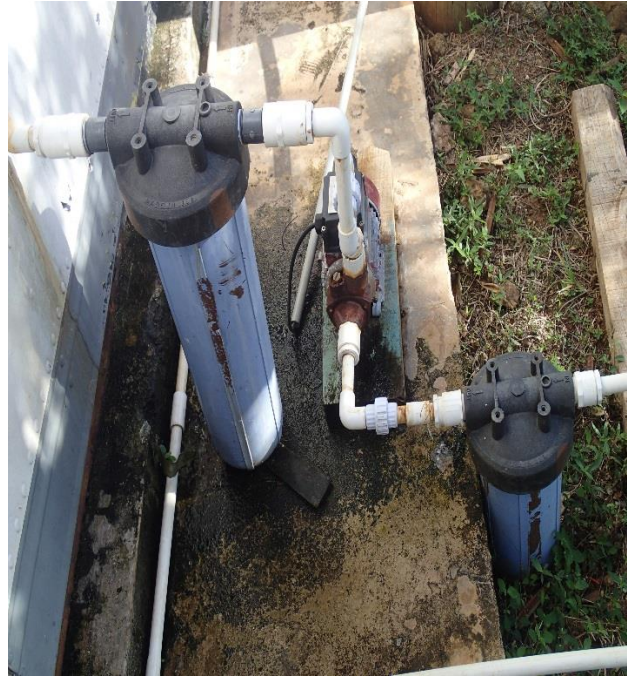
J. Water filter

<p>18. Operation water is filtered, however the filter has never been changed since installation.</p> <p><u>Recommendation:</u> The ice or stored water in the tank need to be tested for Coliform and E.coli to provide evidence of safety in the use of filter before changing the filter.</p>		√
<p>19. Plumbing adequately installed and maintained and protected against backflow.</p>	√	
<p>20. Floor drainage needs further improvements to allow flow of discharge out into the drainage system. No water bath at the entrance of the ice production room.</p>		√
